POSTFLIGHT EVALUATION OF ATLAS-CENTAUR AC-5

(Launched March 2, 1965)

Centaur Project Office

Lewis Research Center
Cleveland, Ohio

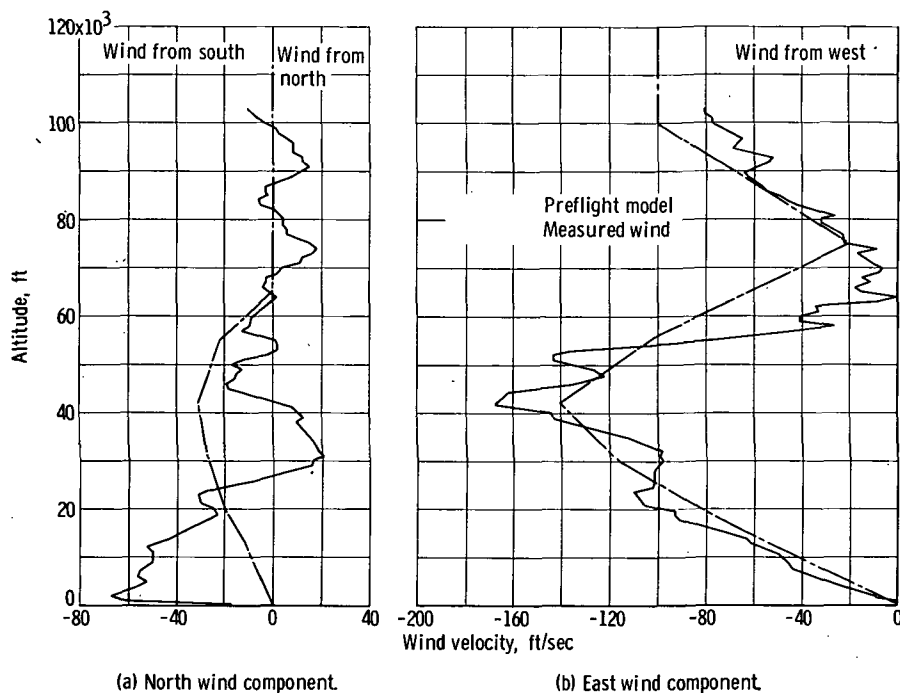
Figure III-1. - Wind conditions measured prior to AC-5 launch as determined by Rawinsonde run at 0824 EST on March 2, 1965 (preflight data).

The atmospheric conditions on launch day were favorable. All wind velocities (fig. III-1) were within vehicle specification, and the conditions for photographic coverage were excellent.

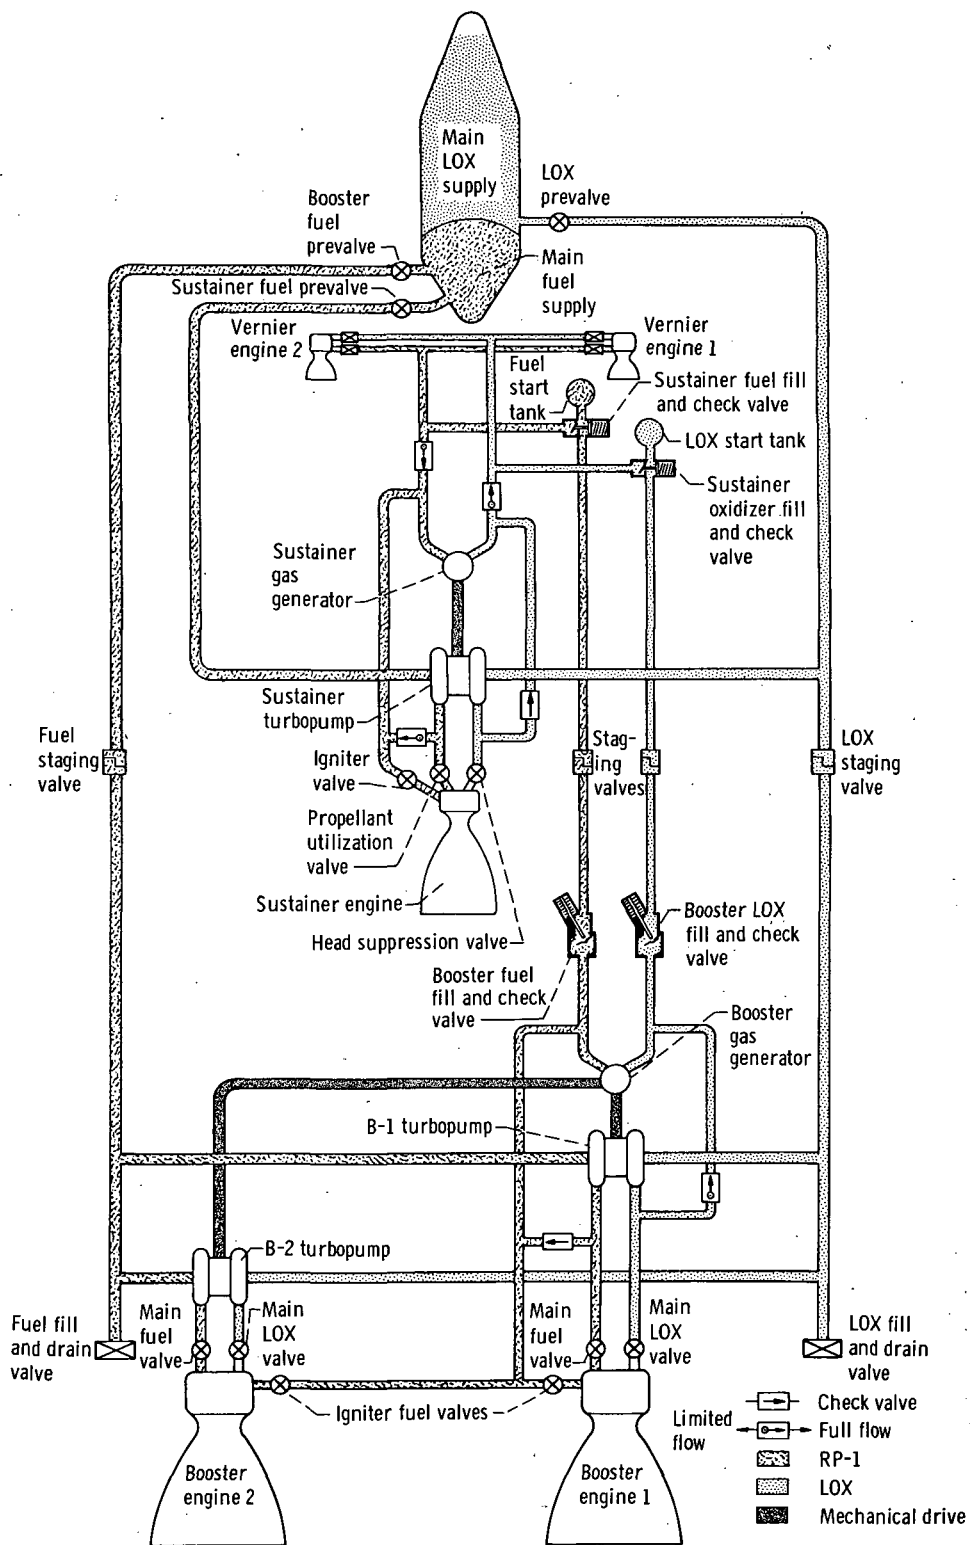
Figure V-1. - Propulsion system schematic.

The fuel system from the main supply tank to the engine injector contains a pre valve, a staging valve and disconnect, a turbopump, and a main fuel valve for the booster system. The sustainer system has a pre valve, a turbopump, and a propellant utilization (PU) valve. The LOX system has the same elements except that the main LOX valve replaces the main fuel valve for the boosters, and a head suppression valve replaces the PU valve for the sustainer.

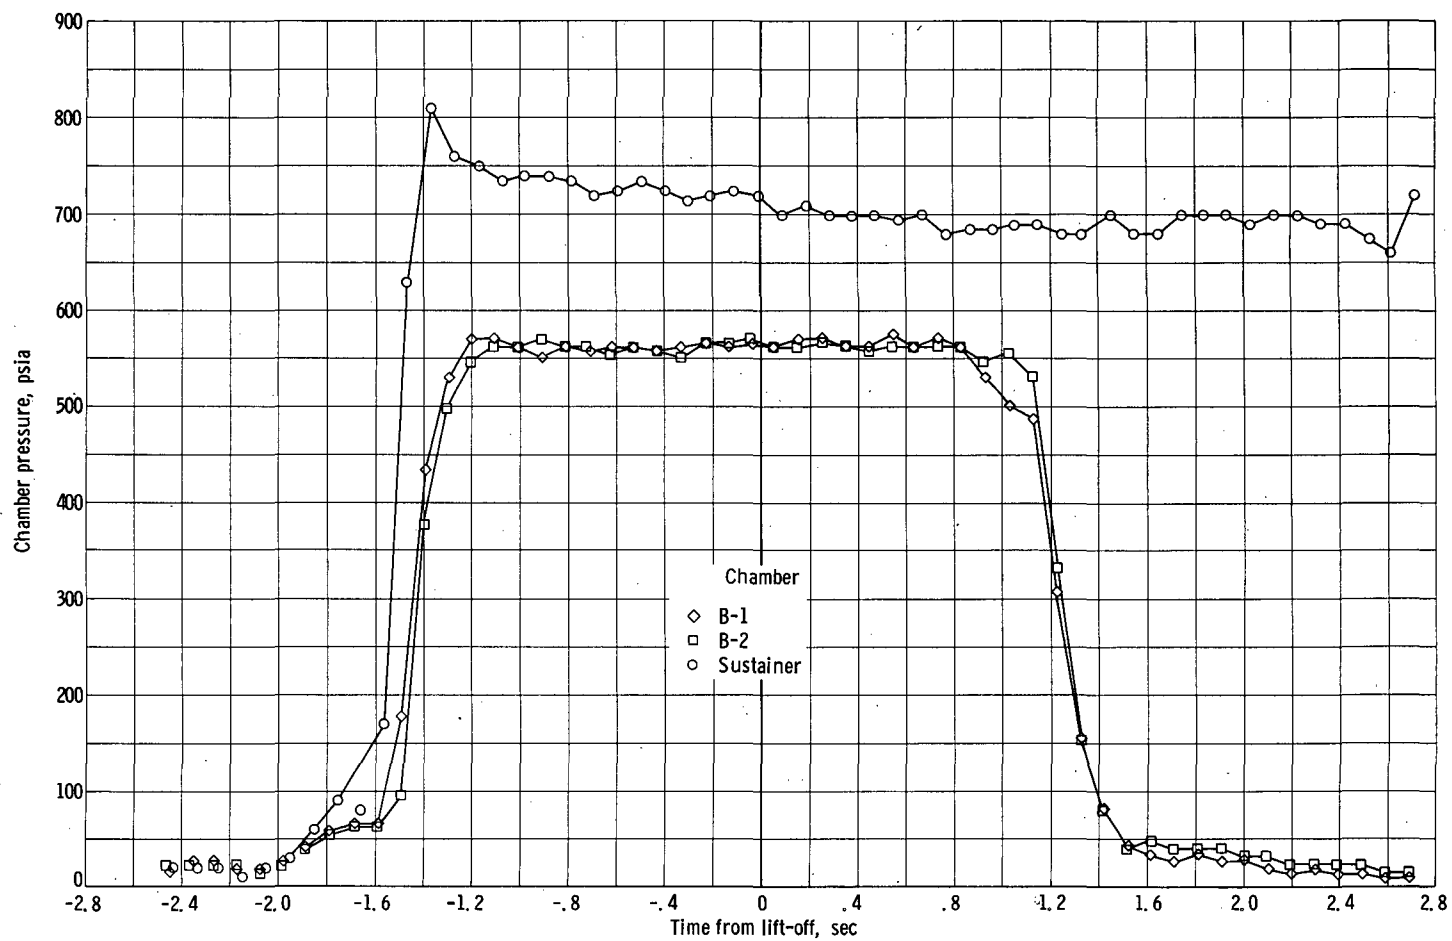
Figure V-3. - Atlas engine chamber pressures for AC-5 flight.

All Atlas propulsion system parameters were normal through lift-off for the AC-5 launch. Table V-I compares some propulsion system nominal values with those obtained at lift-off on AC-5. The first indication of trouble occurred with the loss of fuel pump inlet pressure (FPIP). From 0.7 to 0.9 second the B-1 FPIP decayed from 56.0 to 5.5 psia, and the B-2 FPIP from 56.0 to 8.0 psia (fig. V-2). Following 1.1 seconds the inlet pressures for both the B-1 and B-2 sides remained below 3.0 psia. The fuel tank ullage pressure remained essentially constant until vehicle disintegration at 2.8 seconds, indicating the source of the problem was somewhere between the main fuel supply and the turbopump inlets. The B-1 and B-2 thrust chamber pressures (fig. V-3) were 560 psia at 0.8 second. At 1.1 seconds, the B-1 pressure was 487 psia and the B-2 was 530 psia. By 1.5 seconds both chamber pressures had decayed to approximately 40 psia. The sustainer chamber pressure remained normal, approximately 700 psia, until flight termination.

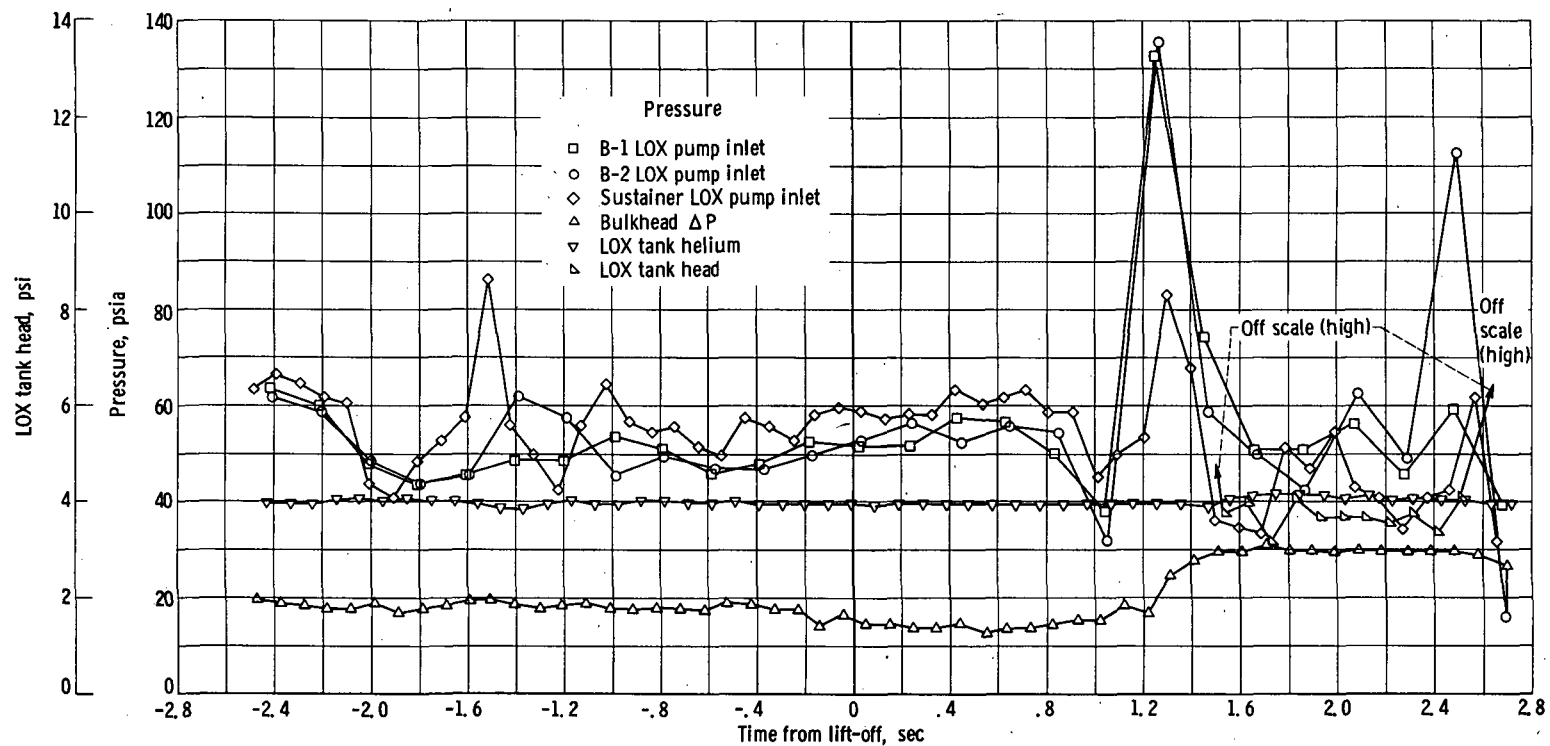
Figure V-6. - AC-5 flight Atlas engine LOX pump inlet pressures bulkhead ΔP .

The B-1 turbopump started to overspeed from its normal speed of 6350 rpm at 0.8 second (see fig. V-5). The B-2 turbopump started to overspeed at 0.95 second with a value of 6150 rpm, reached a peak value of 6850 rpm at 1.1 seconds, and decayed to 1500 rpm by 2.7 seconds. The turbopumps initially oversped because the loss of fuel unloaded the system. The only discrepancies in the sustainer system and the booster LOX system performance (fig. V-6) are considered a result of the vehicle failure.

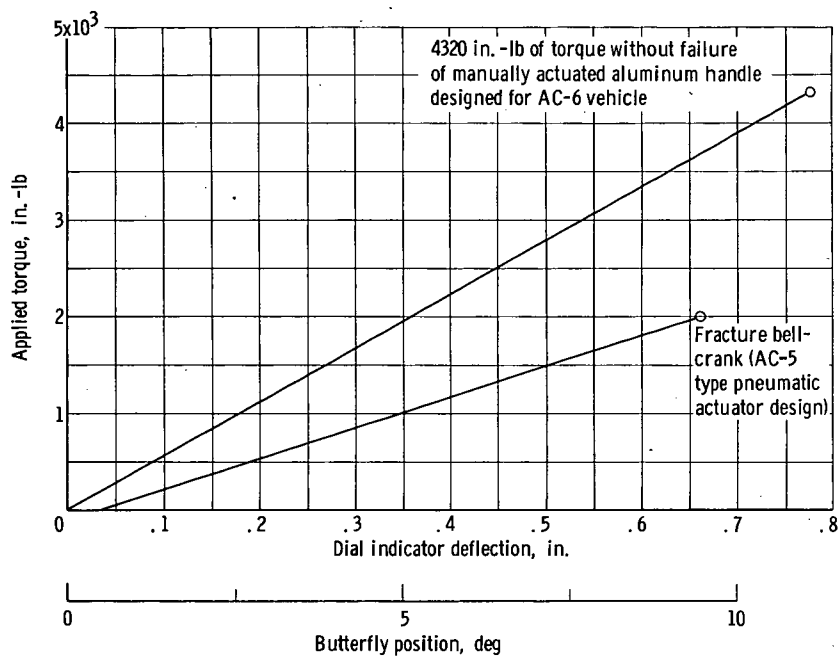
Figure V-17. - Test results of Atlas fuel preclude and actuator static test.

Prevalve. - Examination of hardware after the fire indicated that the pre-valve actuator was unlocked and the butterfly valve was near the closed position. Evaluation of data revealed there was no command given to close the pre-valve. Flow tests indicated the maximum torque that fuel flow can exert on the butterfly valve was approximately 260 inch-pounds. With the prevalve in the locked open position the minimum torque required to cause system failure was de-

If the pre valve failed on AC-5, it did not fail in the locked open position. The valve was either locked and became unlocked prior to failure, or was partially open but unlocked.

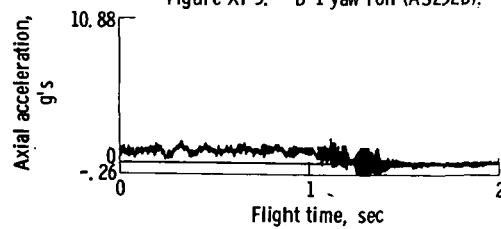
A longitudinal oscillation of 0.8 g P-P amplitude at a frequency of 8 cps occurred at $T + 0.3$ second of flight (fig. XI-4). It was believed that this perturbation was caused by Atlas LOX pressurization instability at lift-off. However, it did not compare well with Atlas LOX pressurization instability oscillations at lift-off of 0.35 g P-P and 6 cps, which have been evident on other Atlas-Centaur flights. More analysis must be performed to ascertain the cause and possible effect from this oscillation.

Figure XI-4. - Axial acceleration (CM101A).
